# KVAADERMAALINGU AVAMINE, KONSERVEERIMINE JA EKSPONEERIMINE EESTI ARSTIDE LIIDU MAJAS TARTUS PEPLERI 32

*Opening, Conservation, and Display of the Quadratura Painting in the Estonian Medical Association Building at Pepleri 32, Tartu*

**DANIEL PETUHHOV**

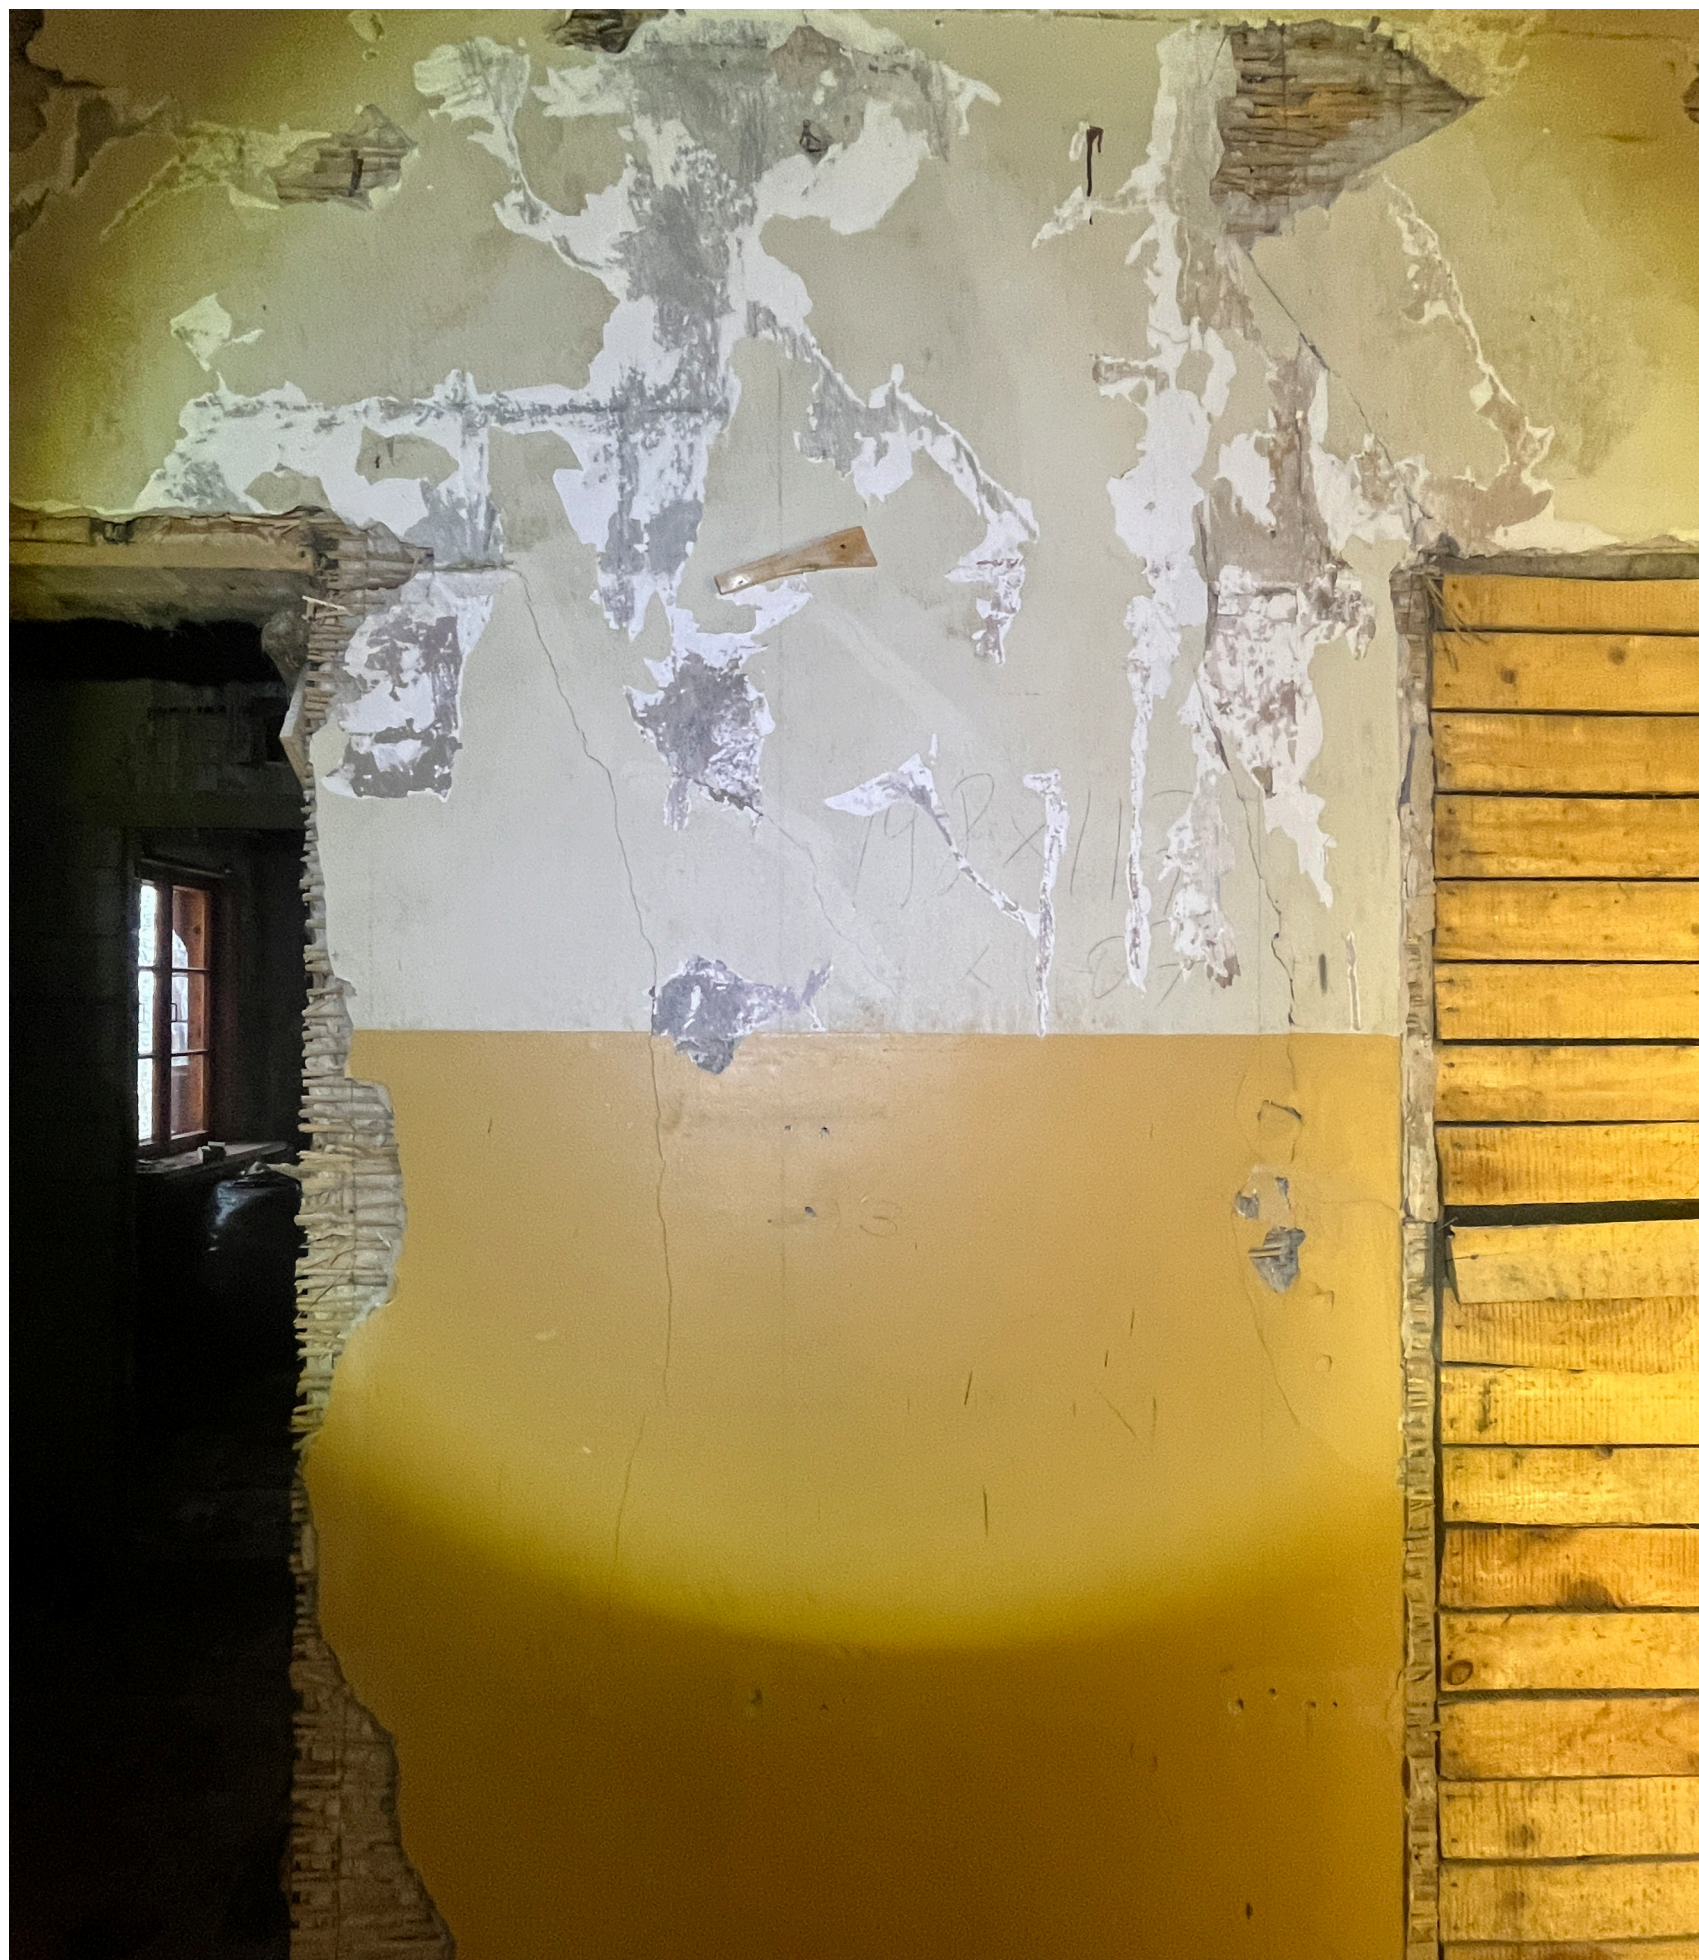
Kvaadermaalinguga sein enne konserveerimist.  
Foto autor: Daniel Petuhhov

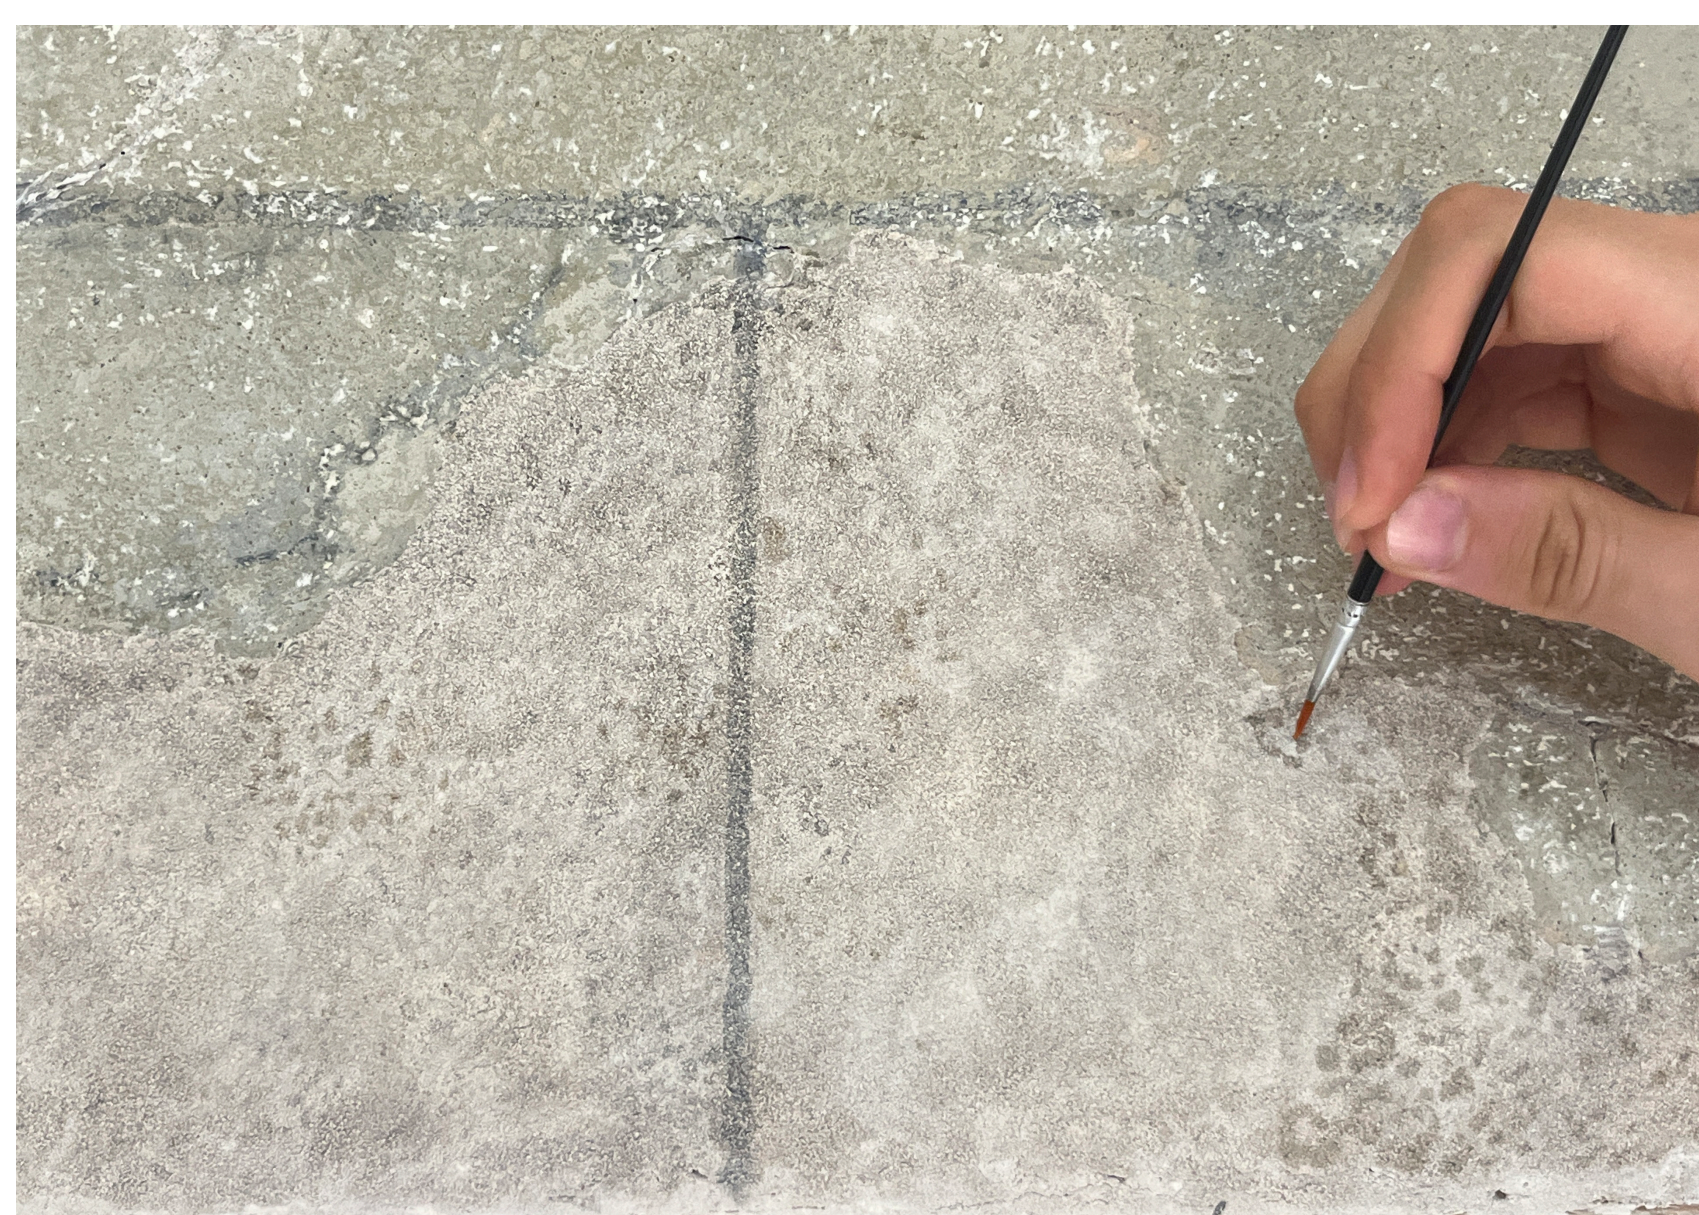
Akvarellvärvidega maalingukadude retušeerimine täpitades.  
Foto autor: Daniel Petuhhov

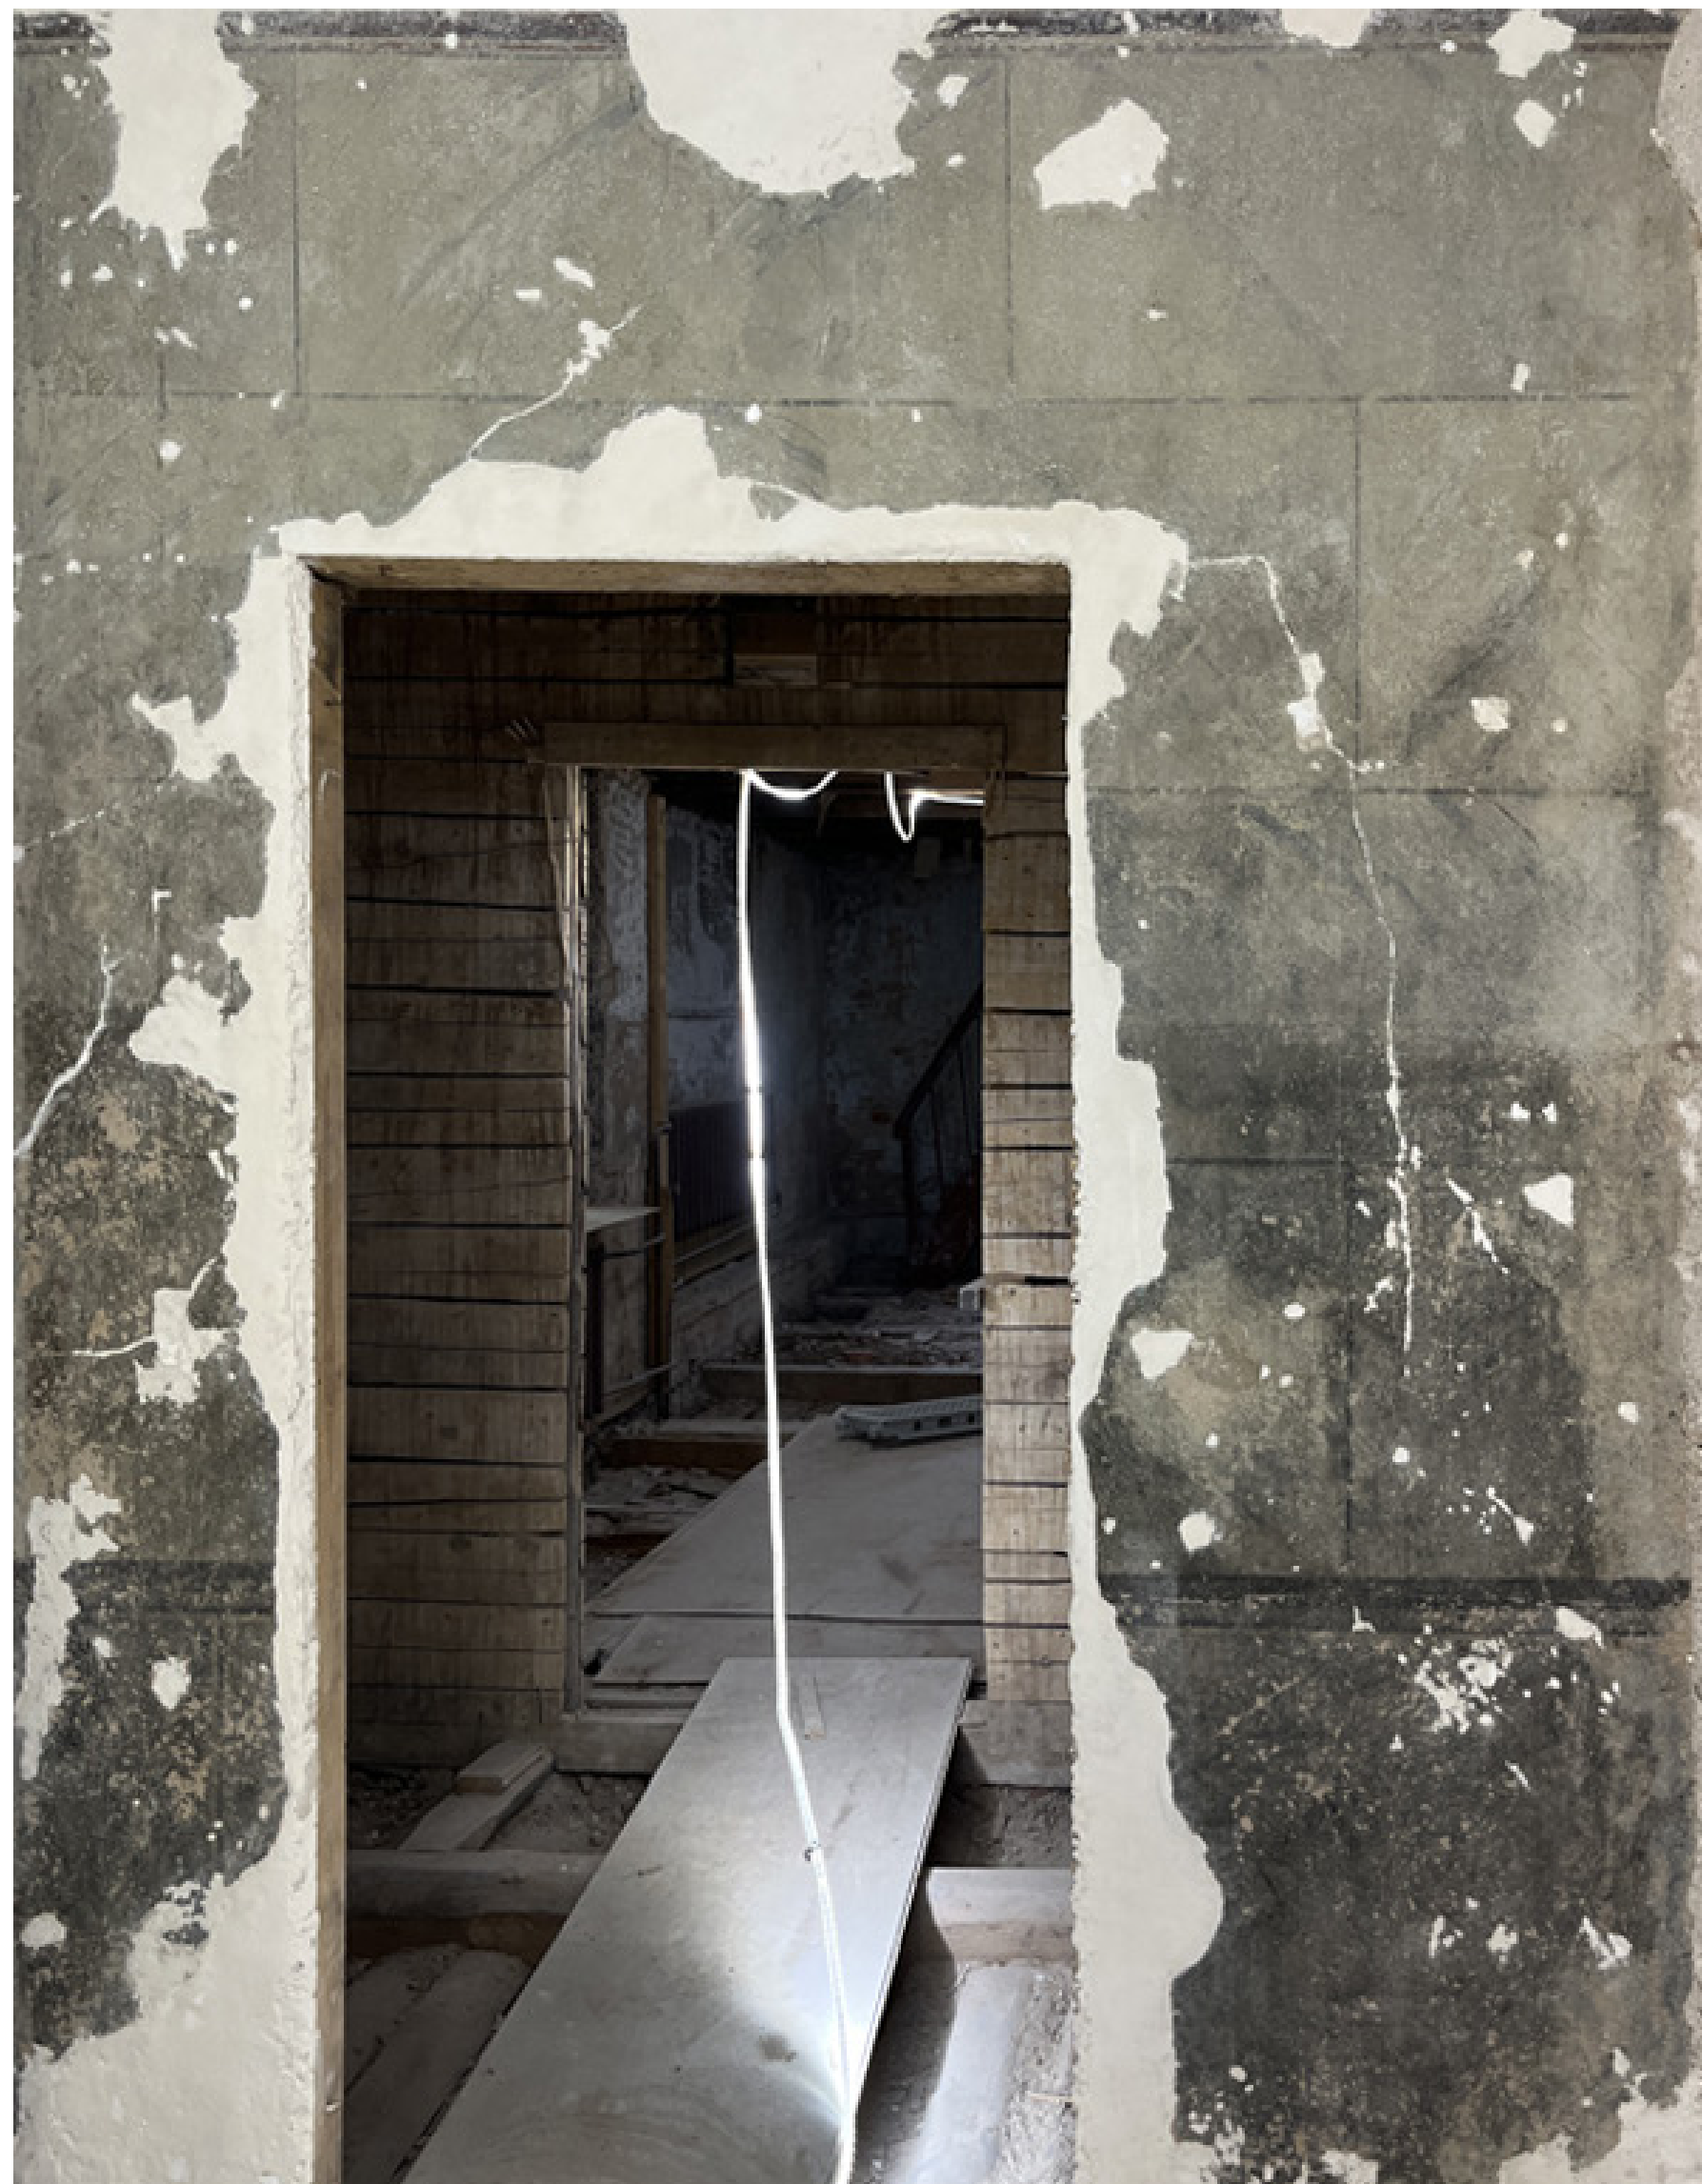
Kvaadermaalingu krohviparandused enne ja pärast retušeerimist. Fotode autor: Daniel Petuhhov

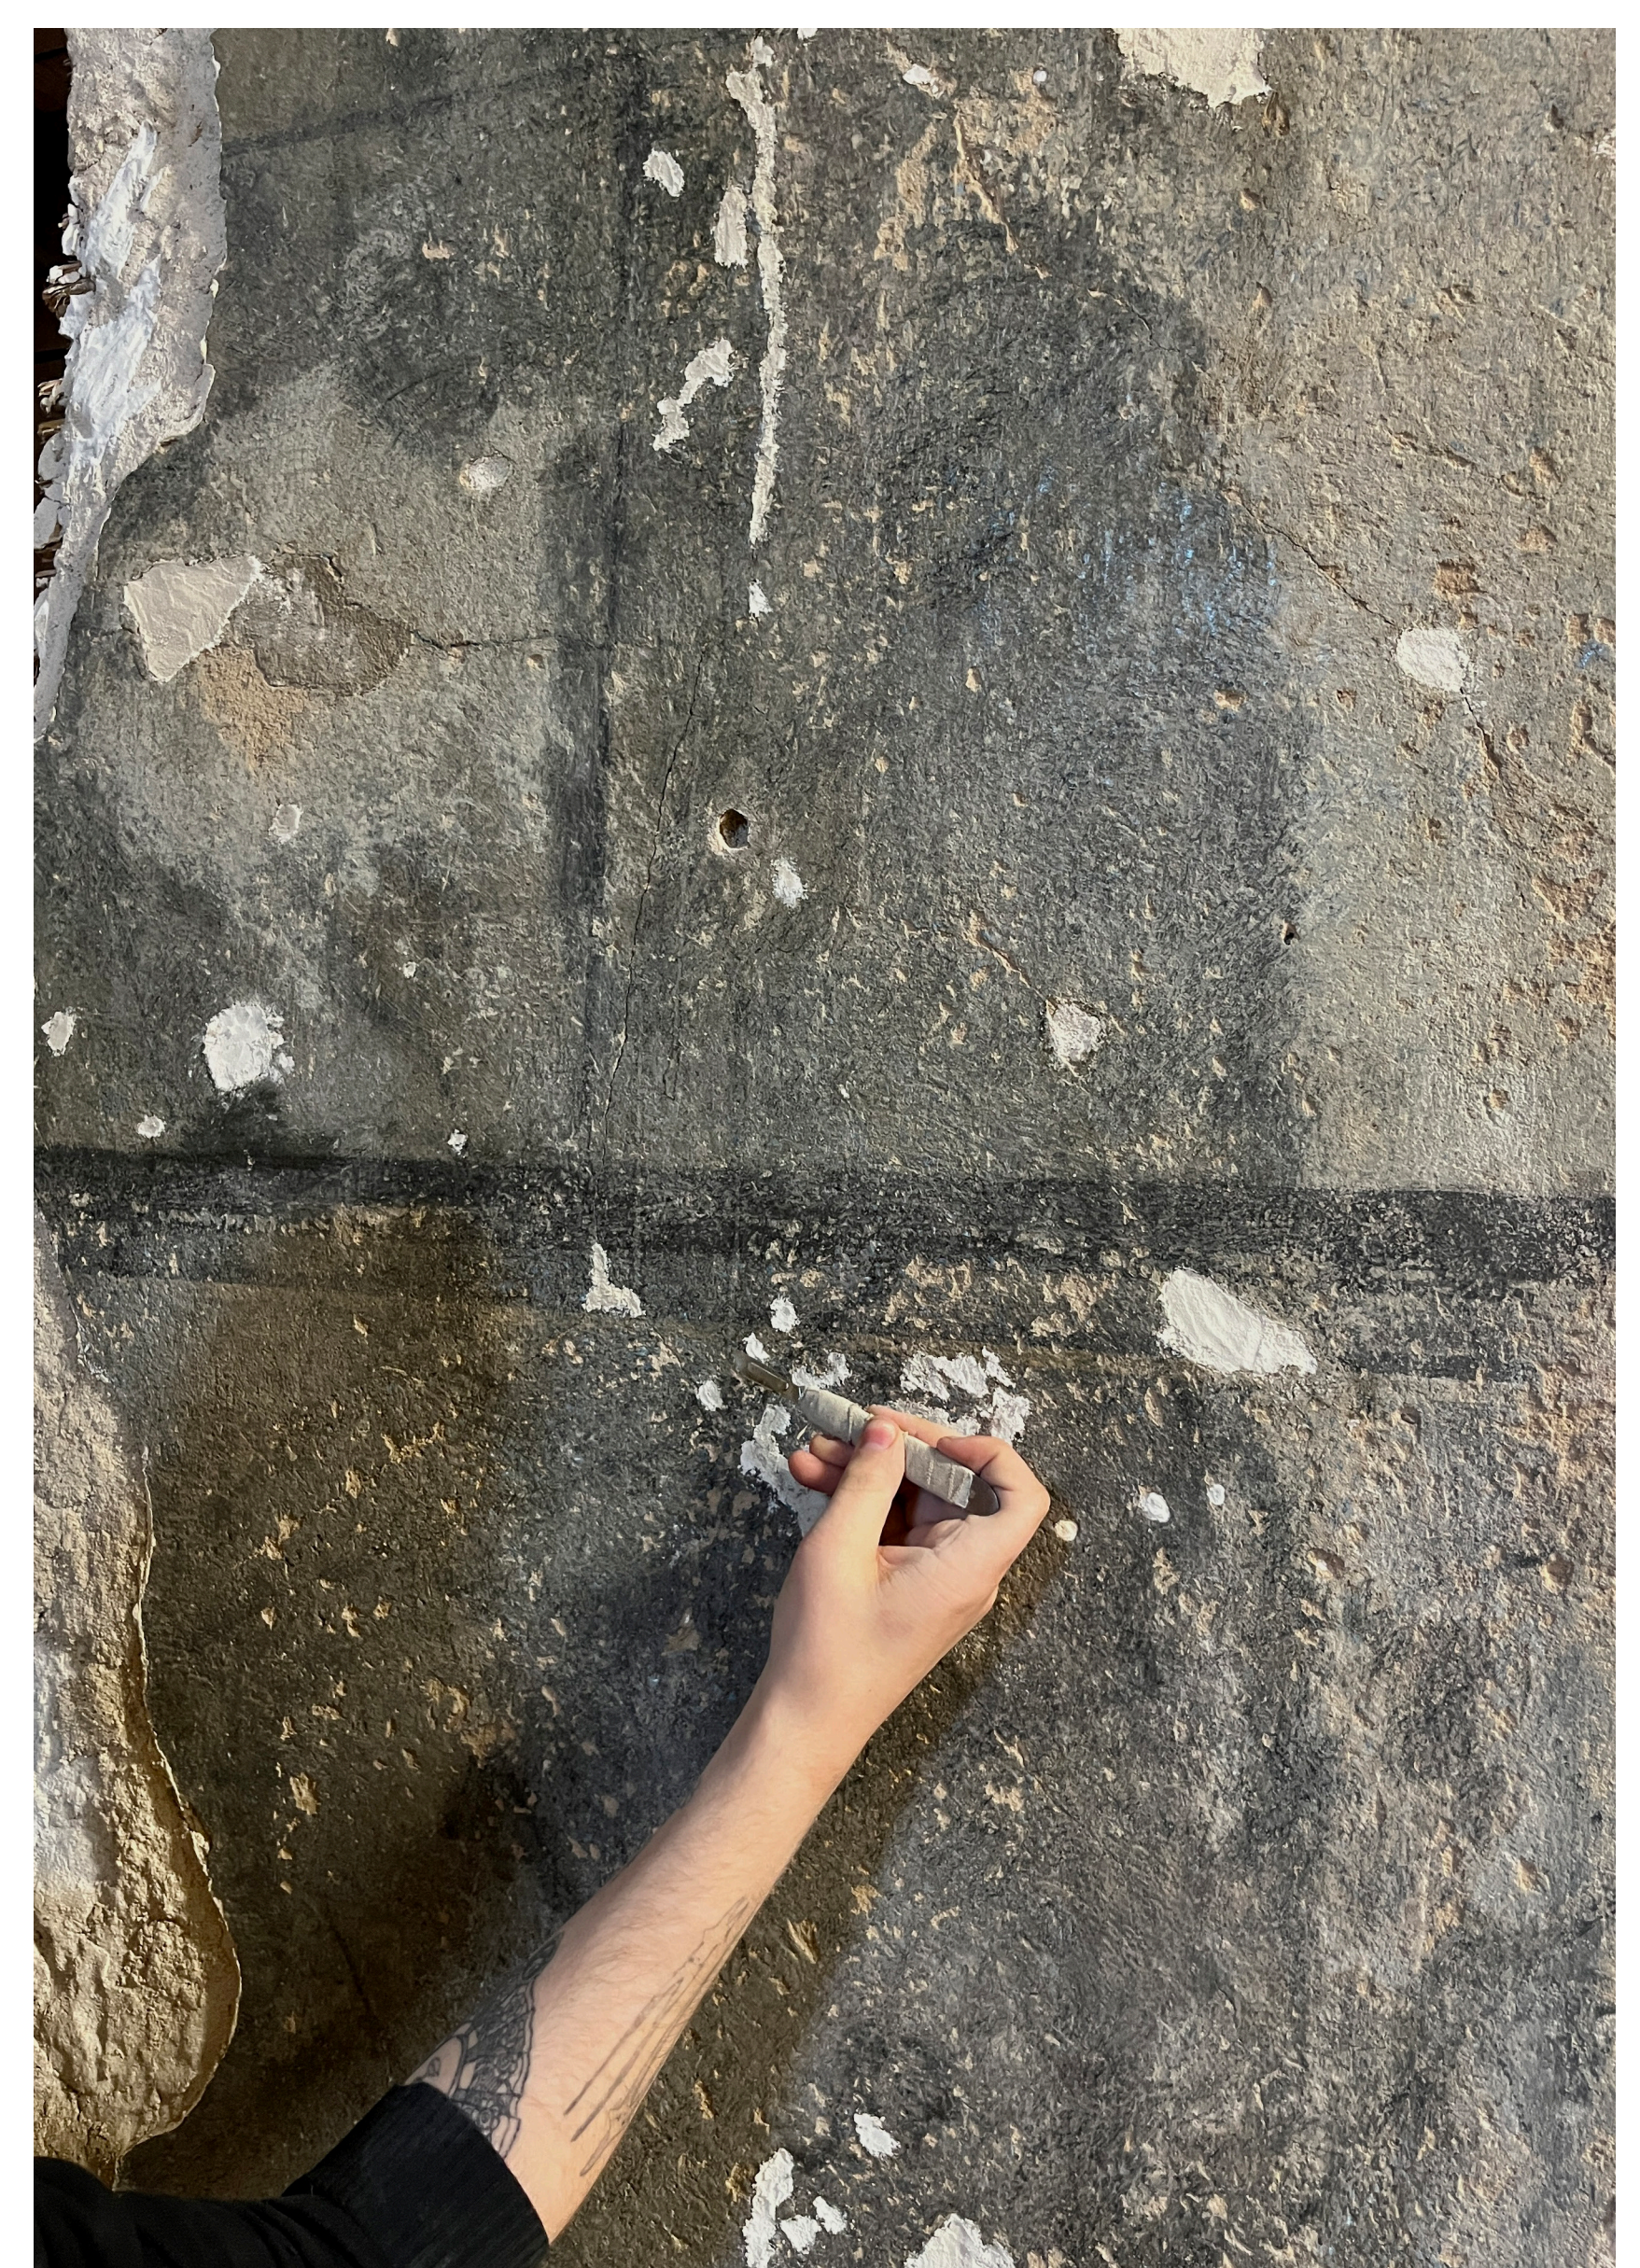
Kvaadermaalingu peenpuhastus skalpelliga.  
Foto autor: Rafael Koi
